# Inspection Report

1005 NW 3rd Pl  
Cape Coral FL 33993

## MEF Home Inspections LLC

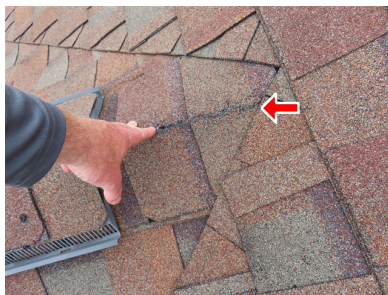
**1.5 Item 1 (Picture)**

2 ridge cap shingles at front gable over porch are damaged and needs replaced by a qualified roofing contractor.

2 ridge cap shingles at front gable over porch are damaged and needs replaced by a qualified roofing contractor.

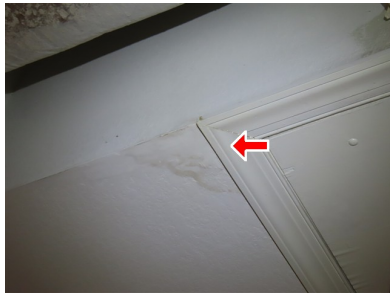
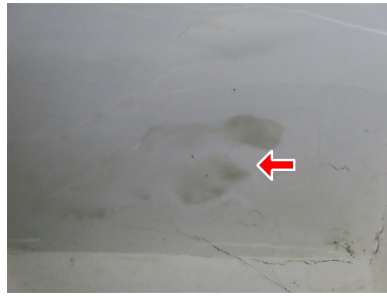
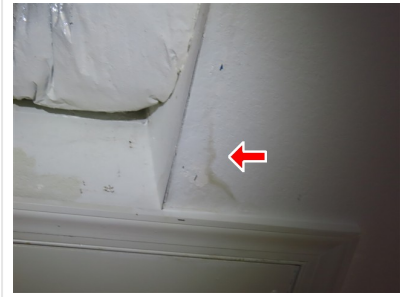
2.4 Item 1 (Picture)

Garage ceilings exhibited evidence of water leakage. The moisture meter showed no elevated levels of moisture in the ceiling materials at the time of the inspection, indicating that leakage has not been recent. The lack of elevated moisture levels may be an indication that the source of leakage has been corrected. You should ask the seller about this condition.

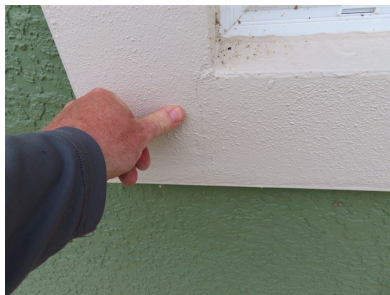
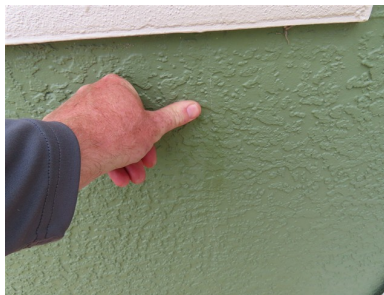
**5.4 Item 1 (Picture)**  
Right side

Minor cracking was visible in stucco covering exterior walls of the home. Cracks exceeding 1/16-inch in width should be filled with an appropriate material to prevent future damage from moisture and monitored in the future for continued activity.

Minor cracking was visible in stucco covering exterior walls of the home. Cracks exceeding 1/16-inch in width should be filled with an appropriate material to prevent future damage from moisture and monitored in the future for continued activity.

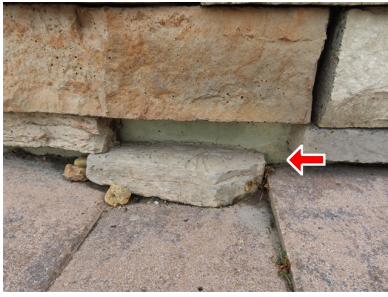
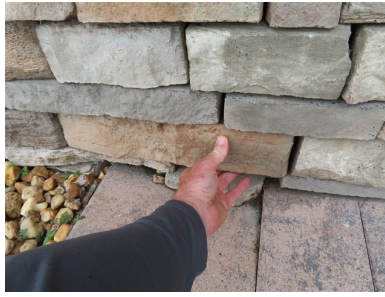
5.5 Item 1 (Picture)

Inspector observed two stones that were loose or missing at the front of dwelling.

Inspector observed two stones that were loose or missing at the front of dwelling.

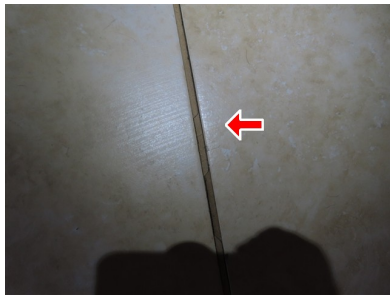
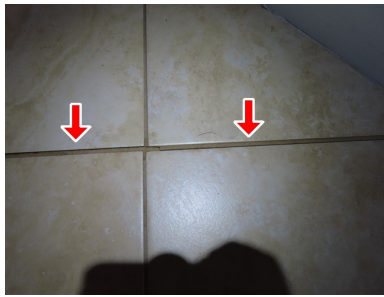
**7.0 Item 1 (Picture)**

(1) Grout maintenance needed at grout floor near office.

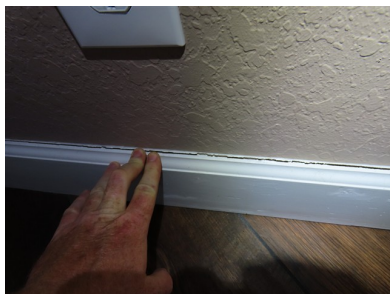
7.8 Item 1 (Picture)

(1) Baseboard trim in office is loose.

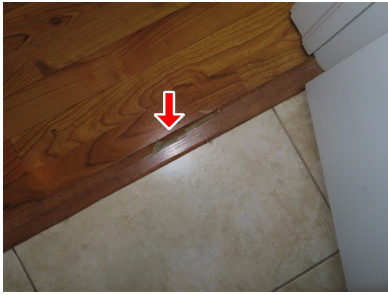
7.8 Item 2 (Picture)

(2) Floor transition strip at 1st shared bathroom is damaged.

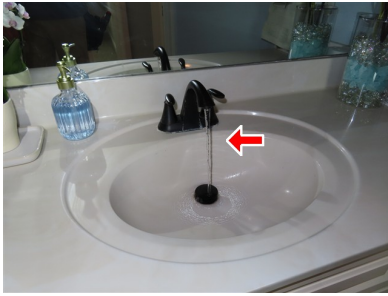
8.4 Item 1 (Picture)

Water flow at the master bathroom sink appeared to be inadequate. The Inspector recommends that this condition be evaluated by a qualified plumbing contractor.

Water flow at the master bathroom sink appeared to be inadequate. The Inspector recommends that this condition be evaluated by a qualified plumbing contractor.

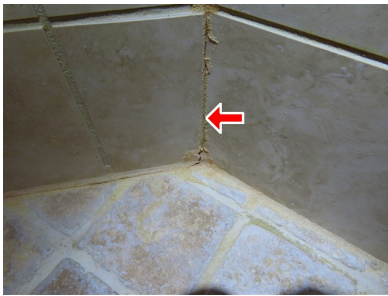
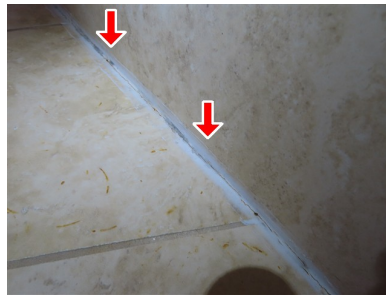
8.6 Item 1 (Picture)

Grout maintenance needed at shower tiles in master bathroom.

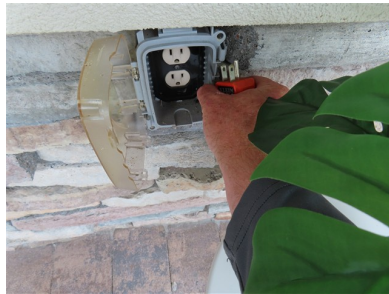
**10.16 Item 1 (Picture)**

(1) An electrical outlet at front porch is loose. Correction should be made by a qualified electrician.

(1) An electrical outlet at front porch is loose. Correction should be made by a qualified electrician.

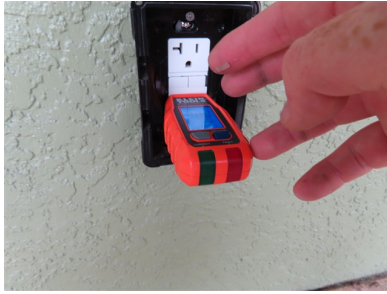
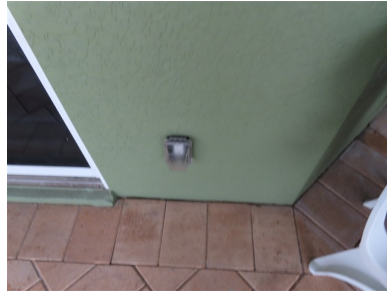
10.16 Item 2 (Picture)

(2) An electrical outlet at rear porch was inoperable when tested. Repairs should be made by a qualified electrician.

(2) An electrical outlet at rear porch was inoperable when tested. Repairs should be made by a qualified electrician.

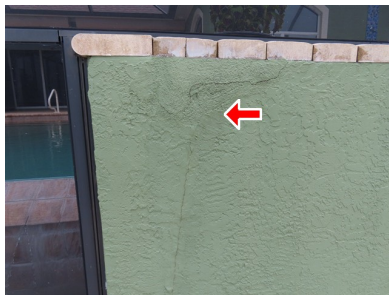
14.0 Item 1 (Picture)

Minor cracking present at stucco wall barrier around pool.

Minor cracking present at stucco wall barrier around pool.

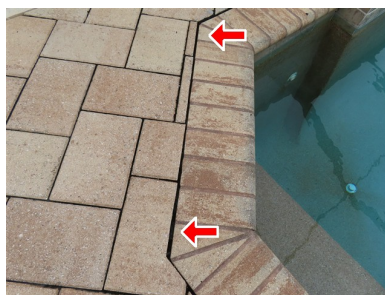
14.3 Item 1 (Picture)

(1) Small gaps between paver decking should be filled with an appropriate sealant.

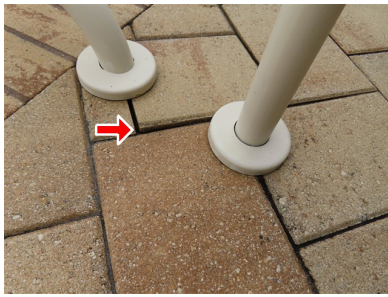
14.3 Item 3 (Picture)

(2) Minor settling in paver pool decking.
